# Manhole Inspection Summary

Manhole # S31GG\_016MH

Insp Date: 1/15/07 1:10 PM

**Location** Address: **241 W LANVALE ST**

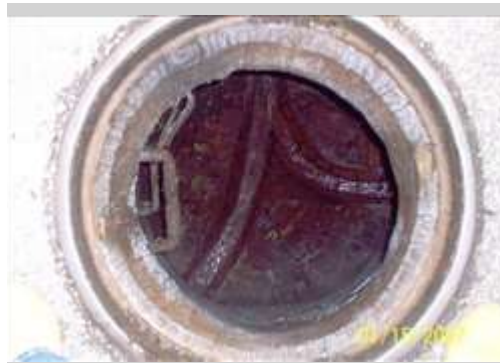
Top View

Corroded steps. Evidence of surcharge - Bench debris.

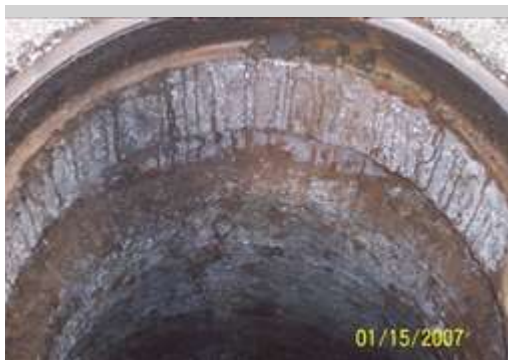
Defect

Frame offset. Adjustment deterioration and infiltration.

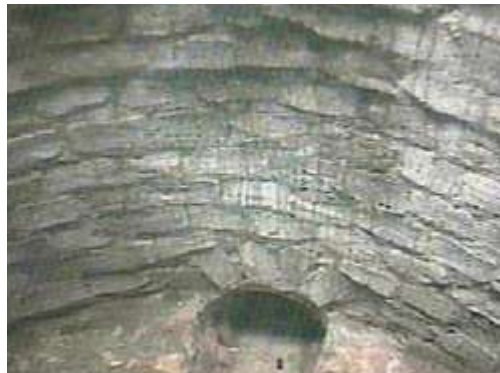
Defect

Barrel infiltration.

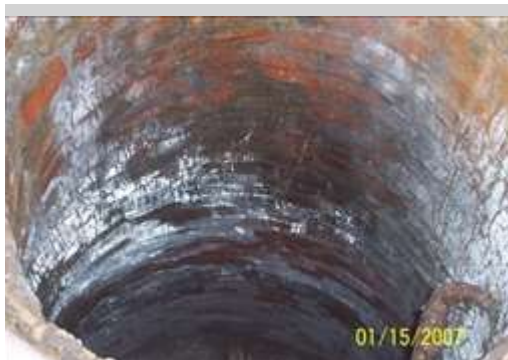
Defect

Corbel and Barrel infiltration.

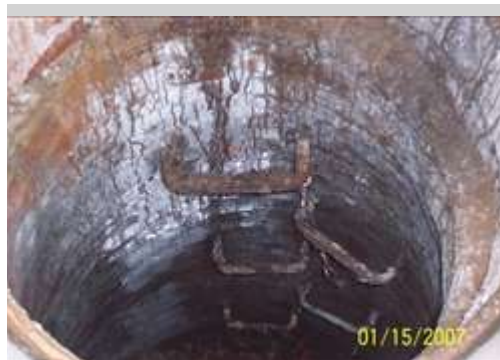
Defect

Frame offset. Adjustment deterioration and infiltration. Corbel and Barrel infiltration.

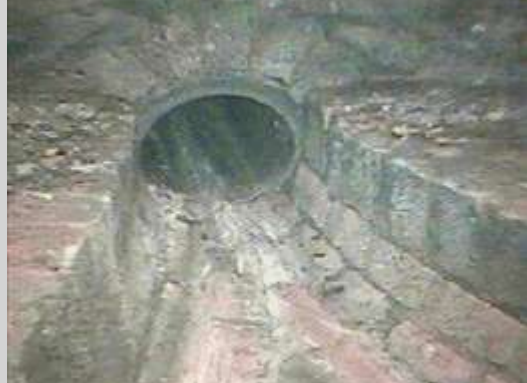
### 8 in. Circular Gravity Sewer Pipe Out @ 12 O'Clock

Channel deterioration.

Deposits: ☐ None ☐ Mud ☐ Sludge ☐ Debris ☒ Grease

Infiltration: **Evidence** Pipe Seal Cond: **Unknown**

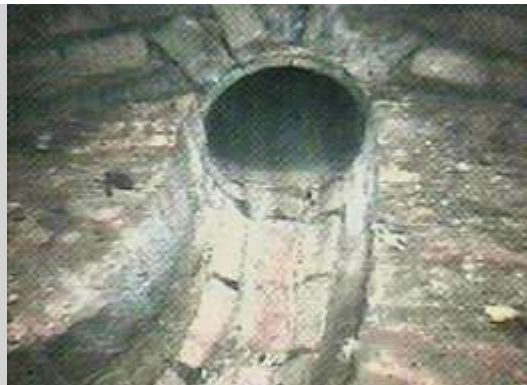
### 8 in. Circular Gravity Sewer Pipe In @ 3 O'Clock

Infiltration: **Evidence** Pipe Seal Cond: **Cracked**

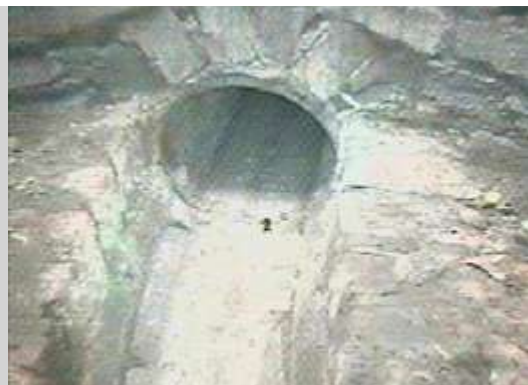
Pipe In @ 7 O'Clock

Infiltration: **Evidence**

Pipe Seal Cond: **Cracked**
